Date: June 15, 2005

Re: *Design Review of Sample Building Hotel / Residential Tower*

1.00 Design Review Summary and Overall Risk Assessment

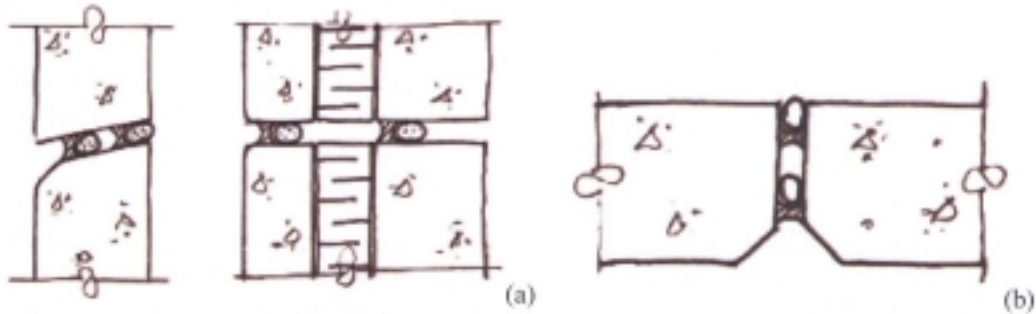
Figure 1 – Example of two-stage joint at precast panels. From: “CHMC’s Best Practice Guide – Architectural Precast Concrete Walls – Overview”

A third-party envelope consultant will provide input on the final design, and a two-stage sealant joint (e.g. similar to the design intent outlined in Figure 1 below is being considered) is being considered. The current drawings (e.g. shown in Figure 2 below) show only a single sealant/backer rod application.

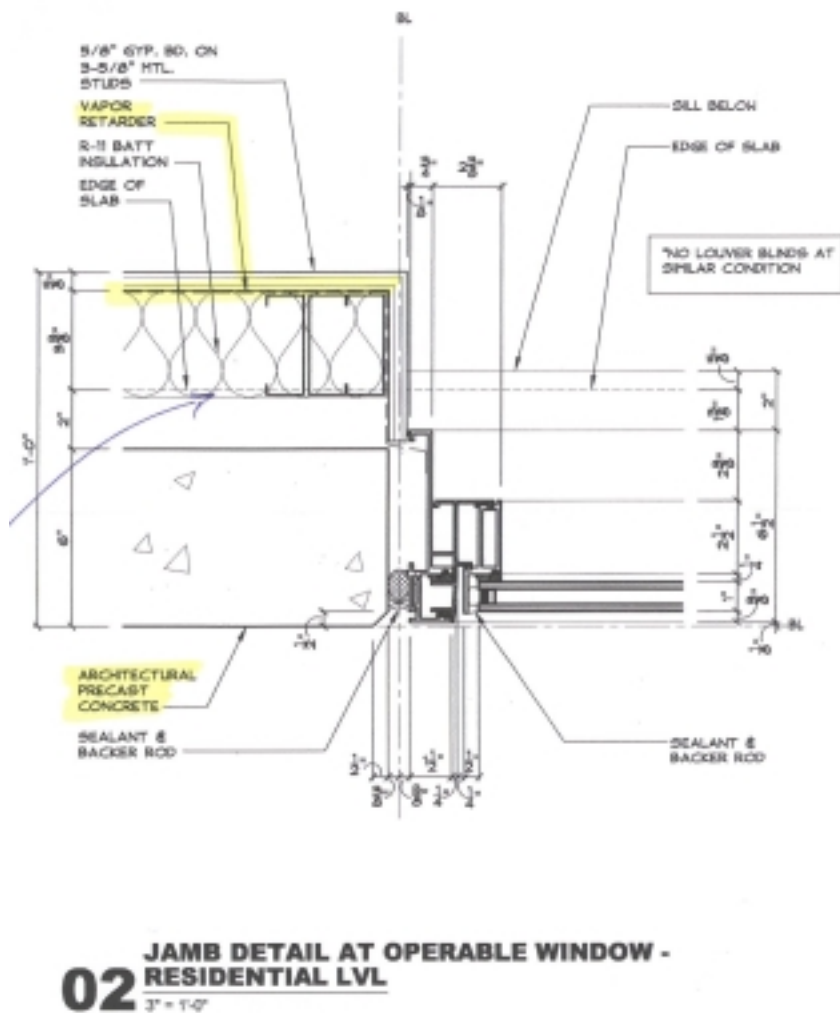
Figure 2 – Window to Precast Panel Jamb Detail from Sheet A6.02/02. One line of sealant and backer rod is currently called out in the drawings

The air barrier at the south/west elevation is not clearly defined in the current drawings. Similar to the discussion in 4.30 above, two lines of defense at the precast panel joints can work to control air leakage. Without the two lines of

sealant, the design relies on the integrity of the punch windows and interior gypsum to control air leakage.

Given the stage of shop drawing development, and involvement of Sample Associates, mSolve is comfortable that air leakage through the precast envelope will be addressed. Identical to the issues addressed above, we request a copy of the final shop drawings that show how air leakage will be controlled on the precast members.
